SPECIAL REPORT ON ANADROMOUS STREAM SURVEYS OF CLEVELAND
PENINSULA, INCLUDING EMERALD BAY, VIXEN INLET, UNION BAY,
CLARENCE STRAIT, BOND BAY, SPACIOUS BAY, AND PORTIONS OF
PORT STEWART AND HELM BAY

Subdistricts 101-90 and 101-80

Volume II

March 1985

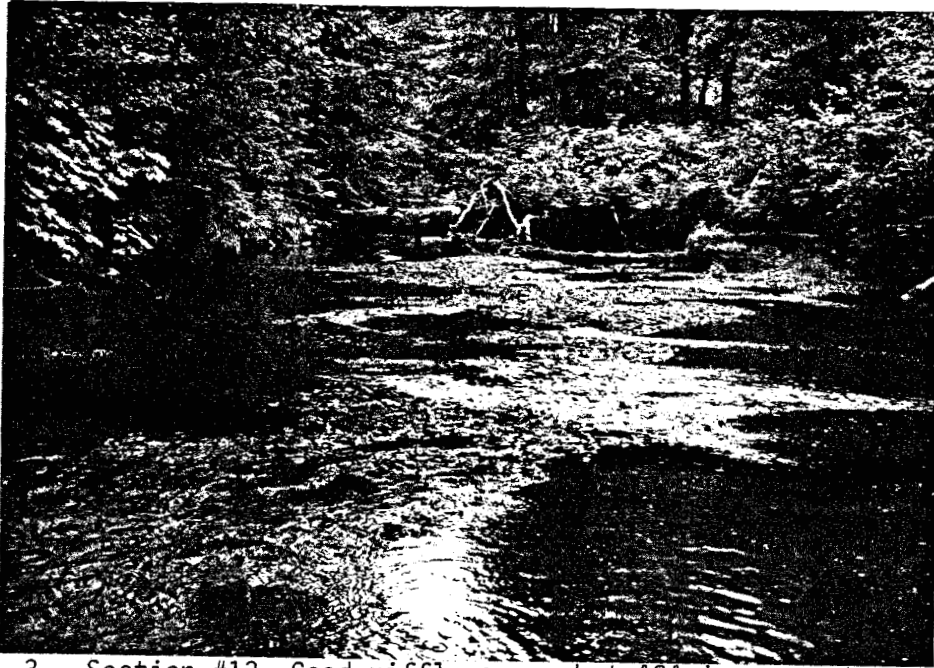
3. Section #13 Good riffle area, but ASA is compact.

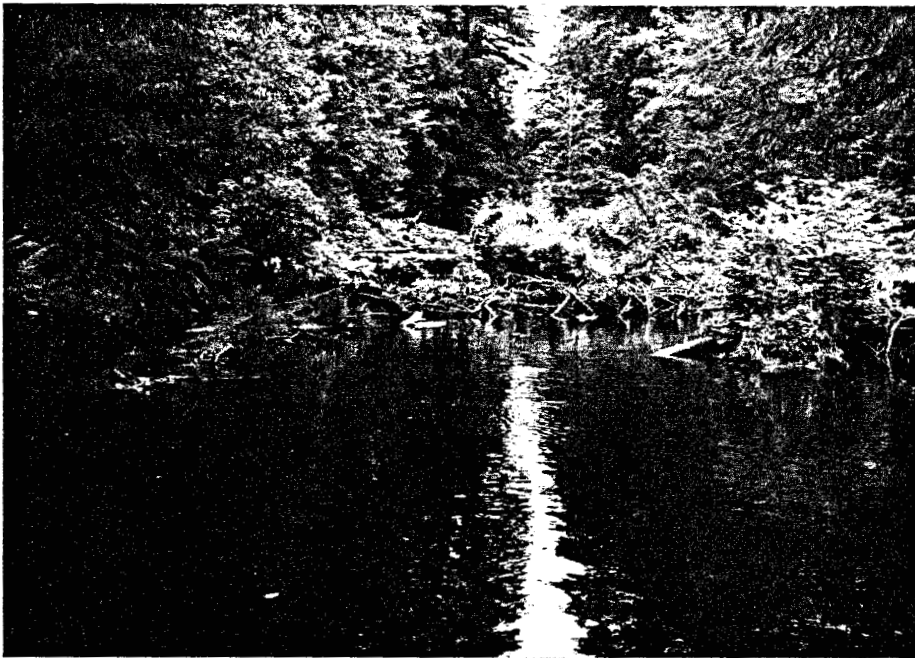
4. Beaver dam 30 m. into Section #14.

Section 14: Large active beaver dam across stream 30 m. into Section. Rearing fish observed above dam.

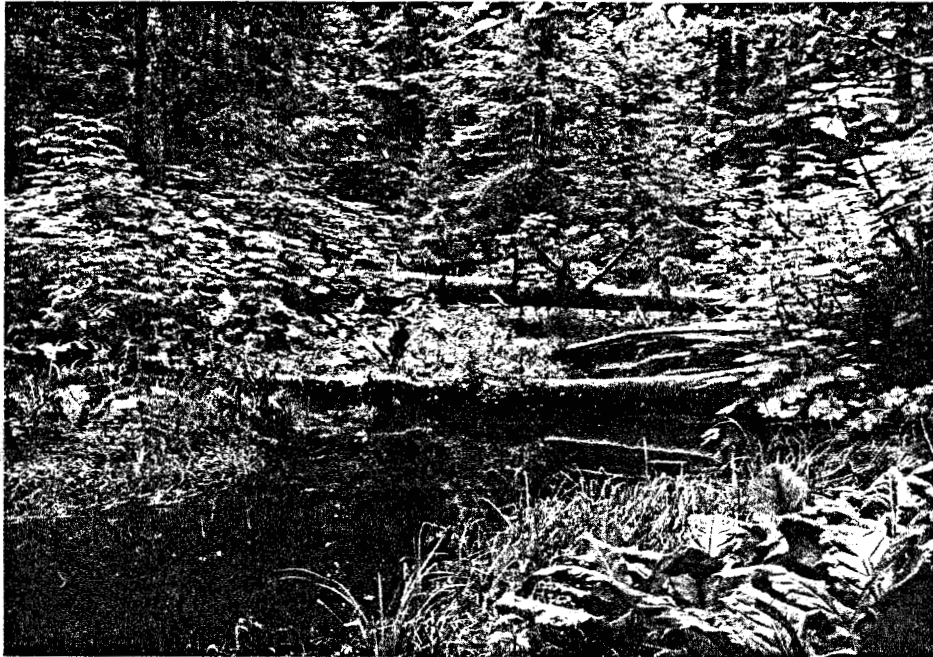
5. 200 m. up tributary from the left bank in Section #15.

Section 15: Twenty five meters into Section tributary enters from left bank. Beaver dams continue up this tributary. The water continues dark and deep up the tributary. Substrate appears to be organic muck. Rearing fish were observed. A reconnaissance by helicopter on 9/4/84 was made of the tributary above the beaver pond area. A stretch of fair ASA and good rearing habitat was found to exist. A few PS were utilizing the area.

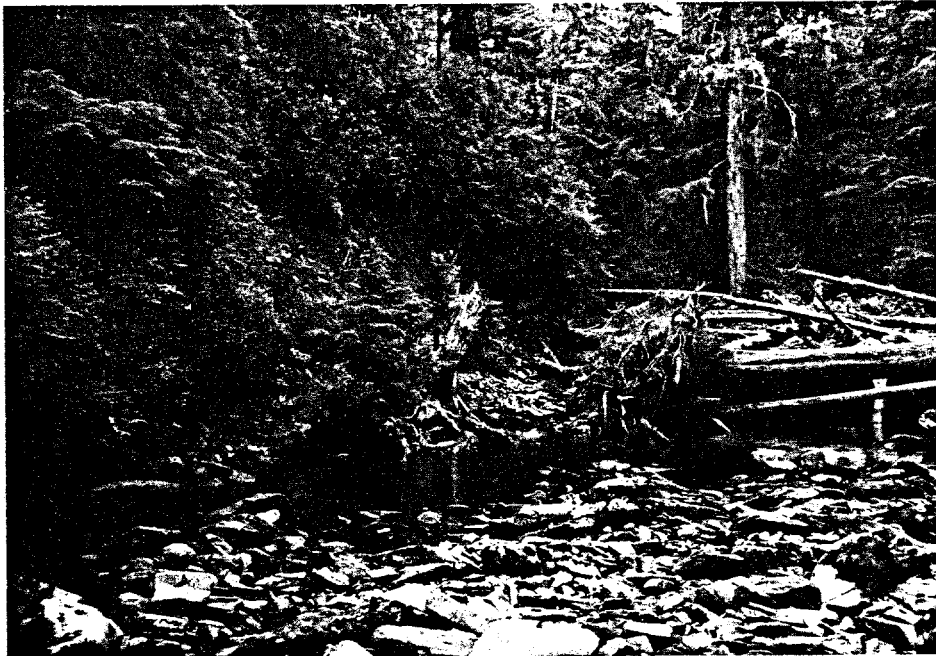
8. Slide area on left bank in Section #27

Section 27: Exposed soil on left bank from slide. Large log jam across stream. Potential difficult obstacle for fish passage. Left bank becomes a rock cliff. Some usable gravel and cobble in riffle area above the log jam but substrate not very loose.

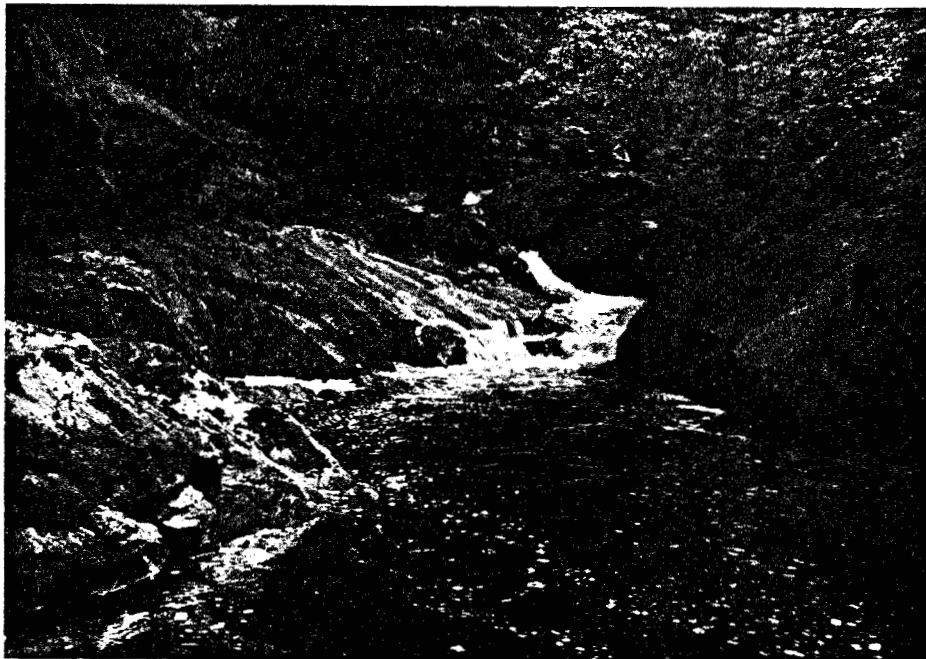
12. Section #39 Possible velocity barrier.

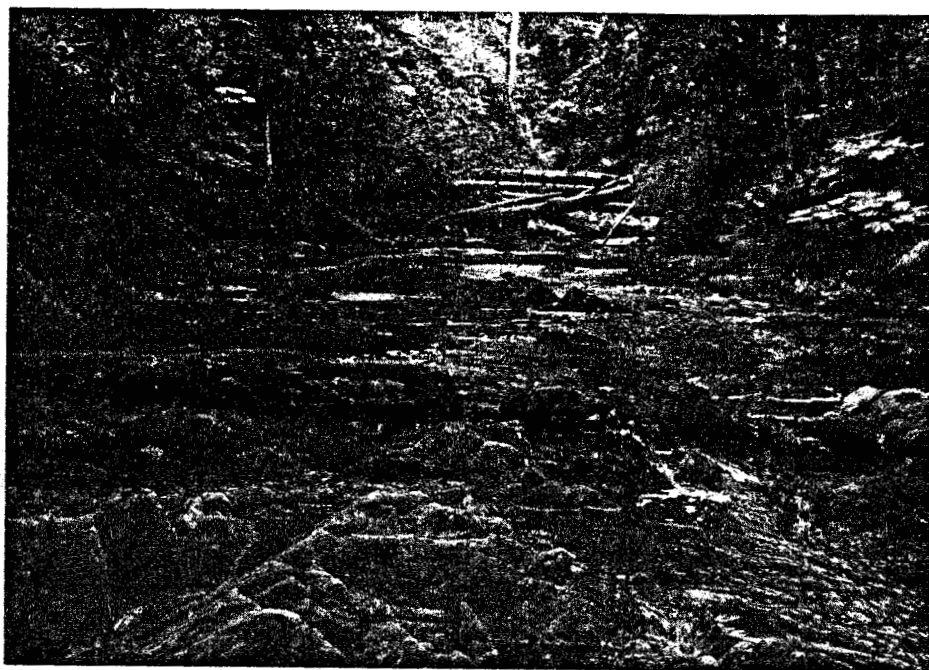
13. Section #49 Substrate consists mostly of bedrock

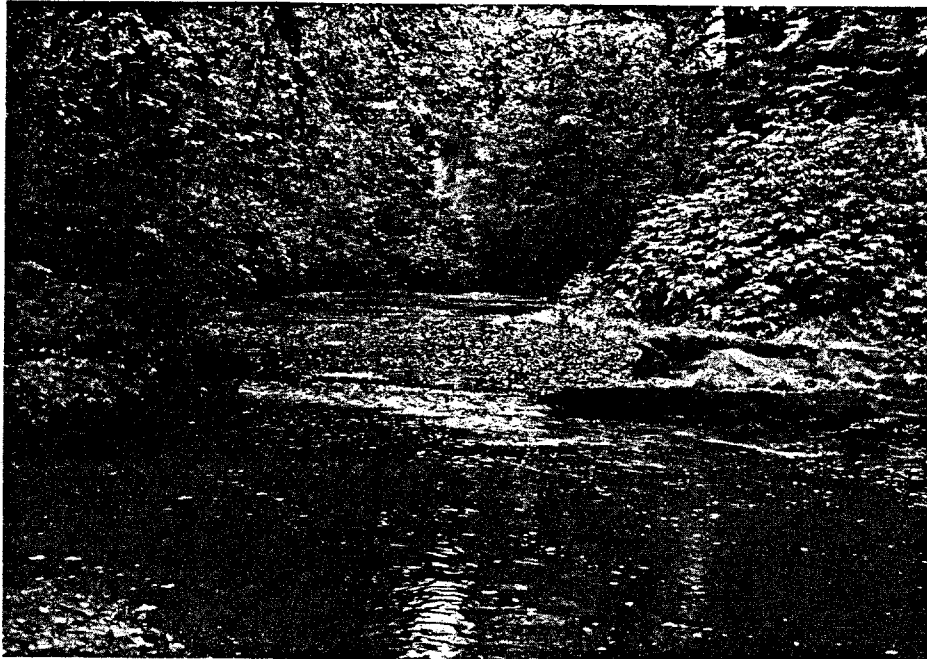
1. Section #1 Good riffle area with many adult pink salmon.

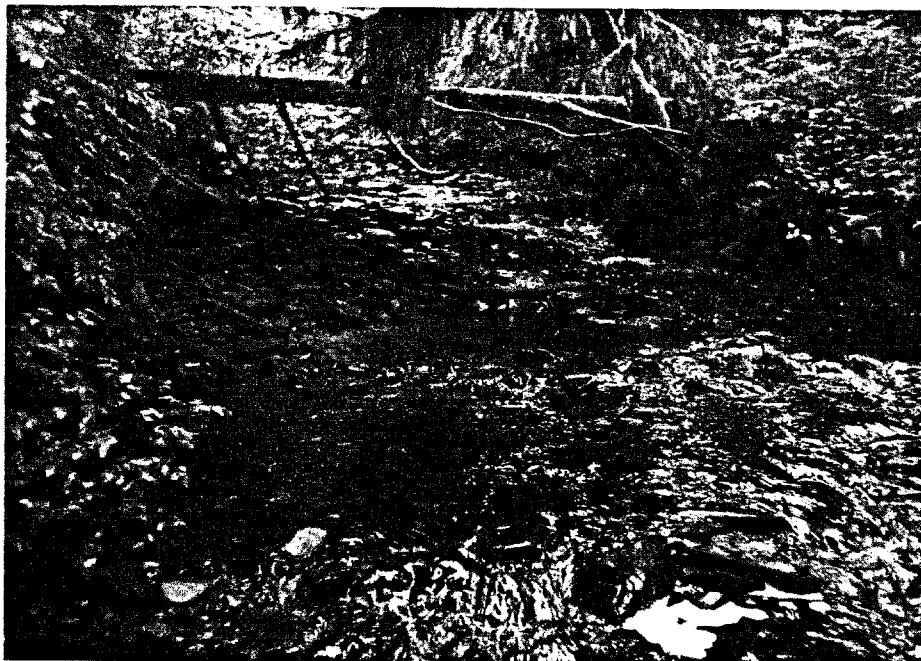
2. Section #5 Larger angular substrate with few adult pink salmon.

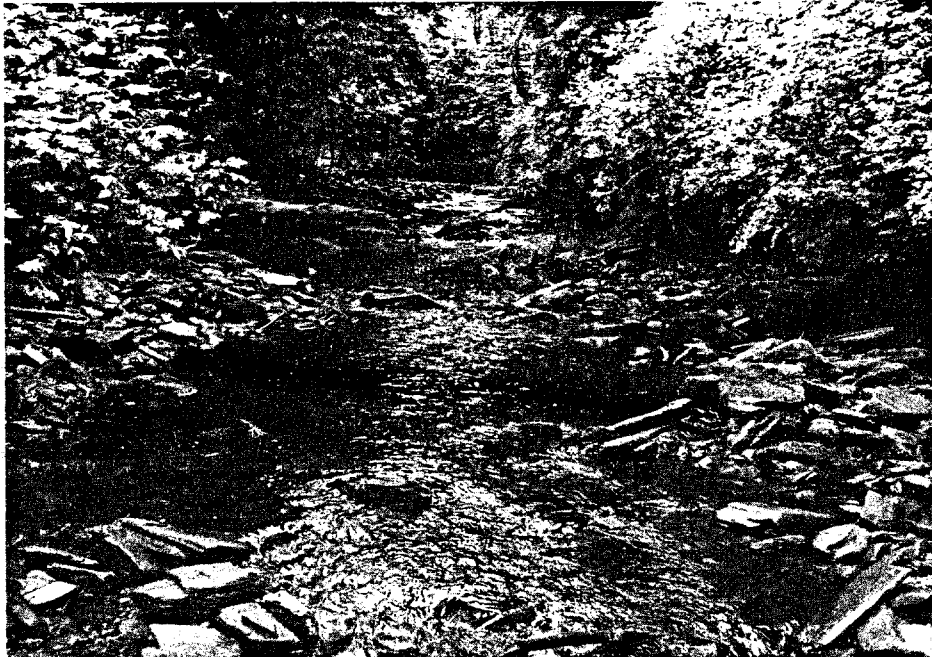
3. Section #6 Large substrate with bedrock along the right bank.

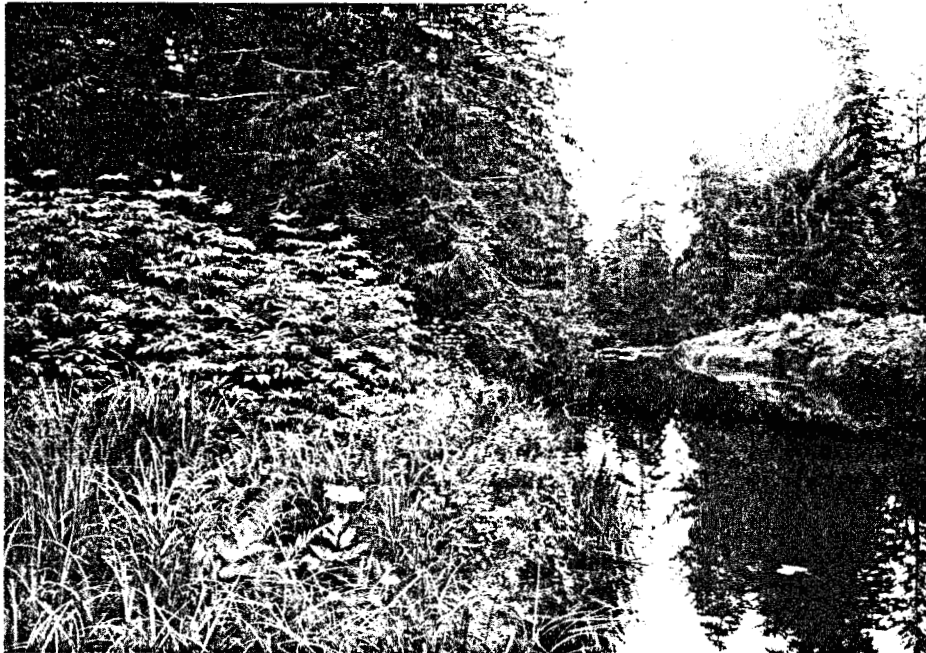
1. Section 2: The influence of the lake was evident in Reach 1.

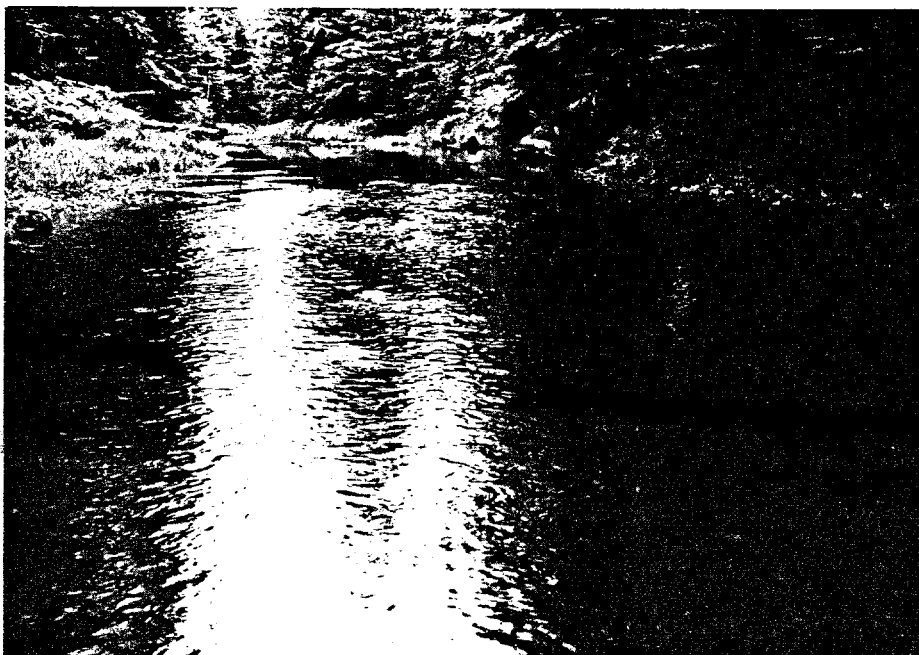
3. Section 16: Reach 2 was characterized by a lack of cover and a large cobble substrate.

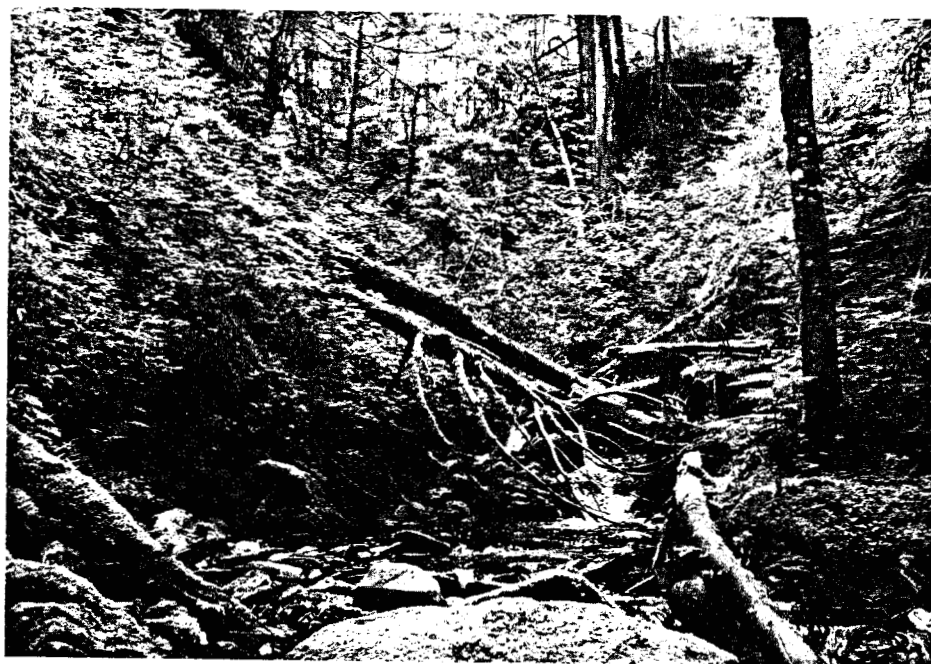
2. Section 19: The stream enters a V-notch in Reach 3 and both the gradient and substrate size increase.

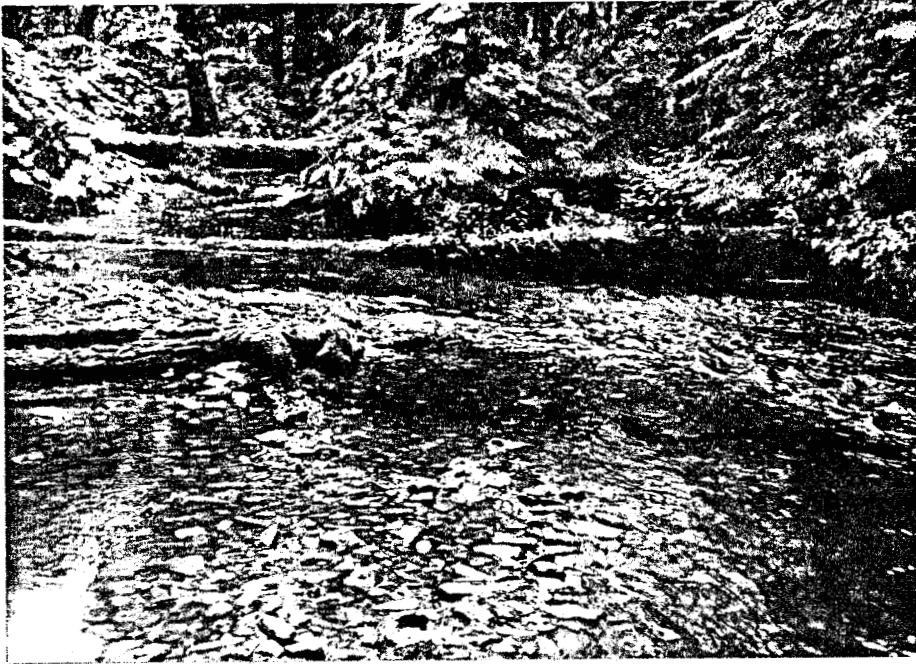
1. Section 2 Good ASA with excellent rearing area.

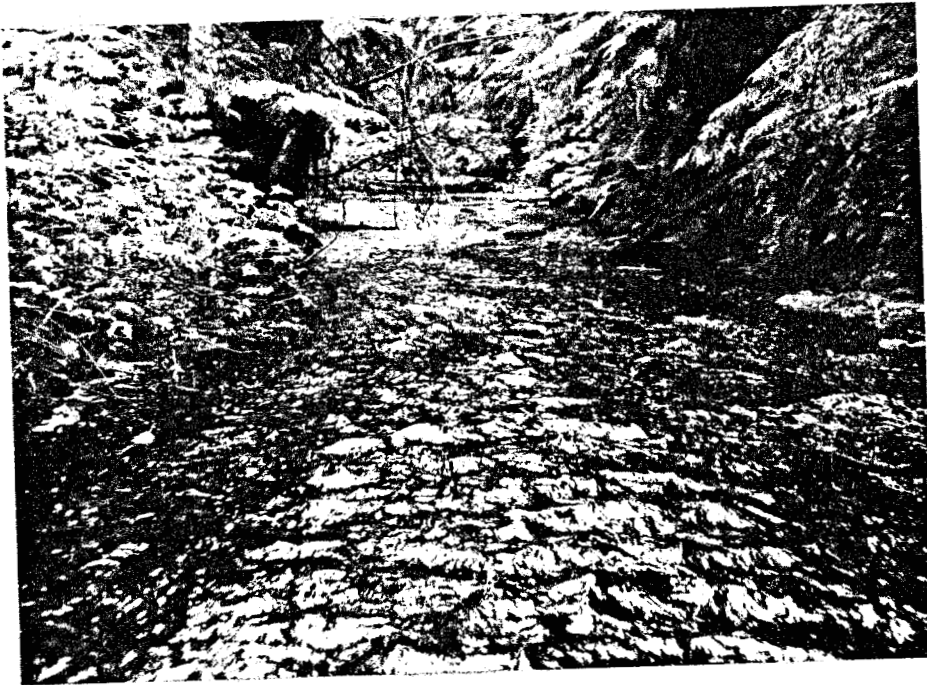
2. Section 14. A few pinks were spawning here but velocity was high.

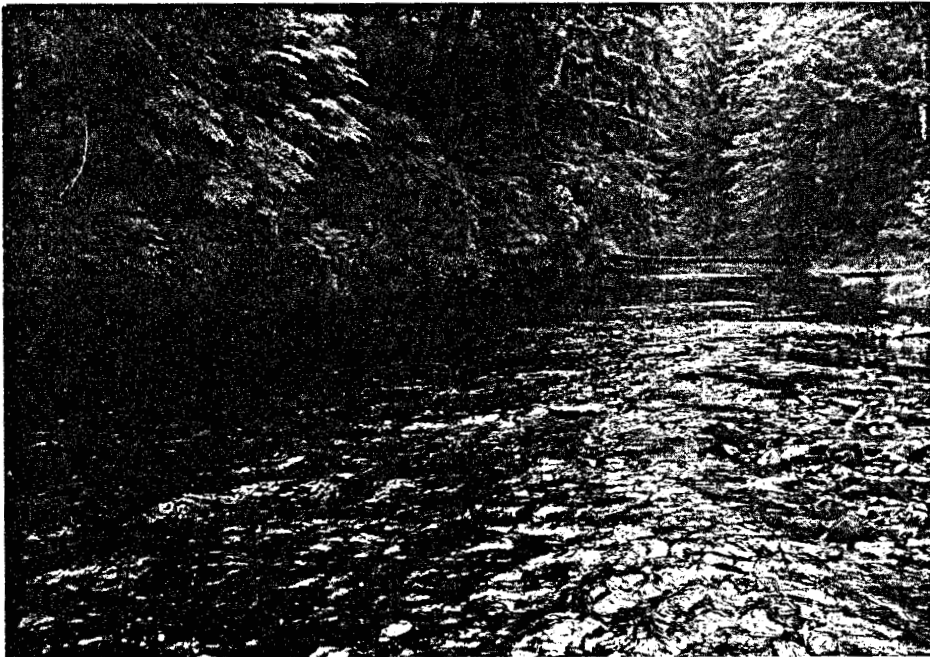
2. Typical habitat in Sections 1 through 3

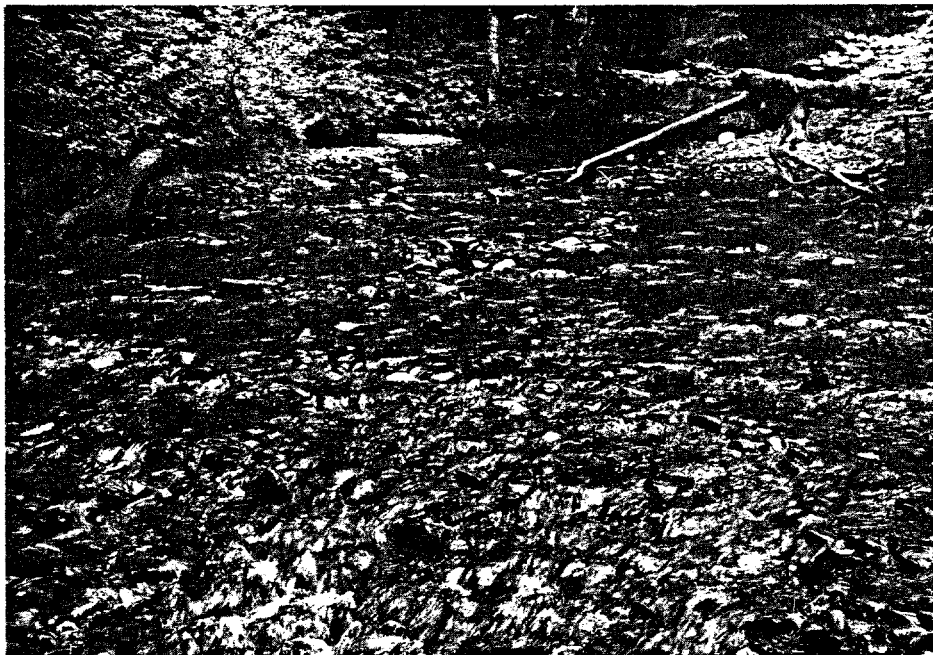
4. Section #15 - Good riffle area

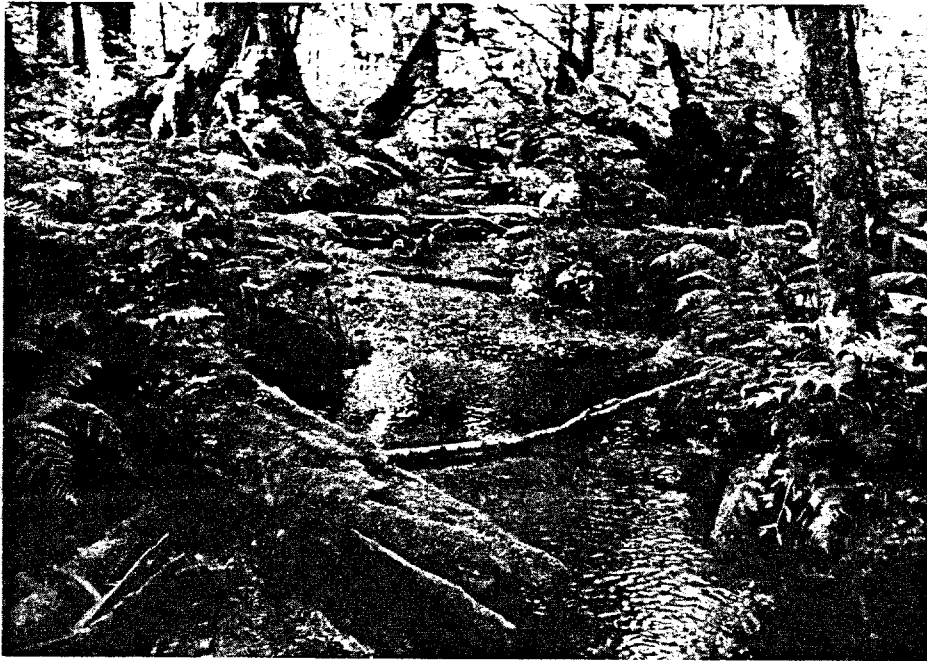
1. 50 m. up the left tributary

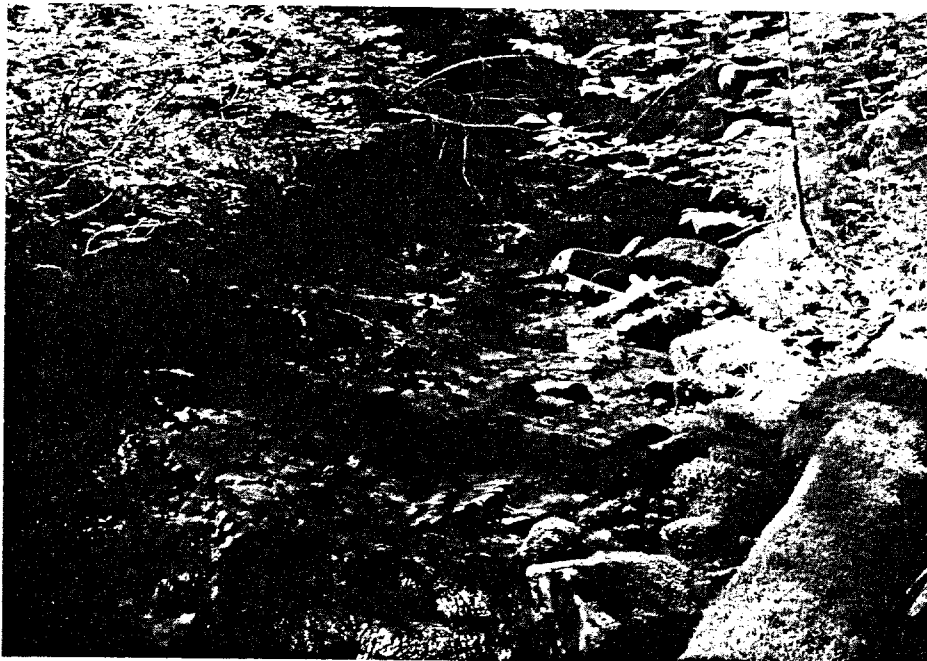
2. 300 m. up the left tributary

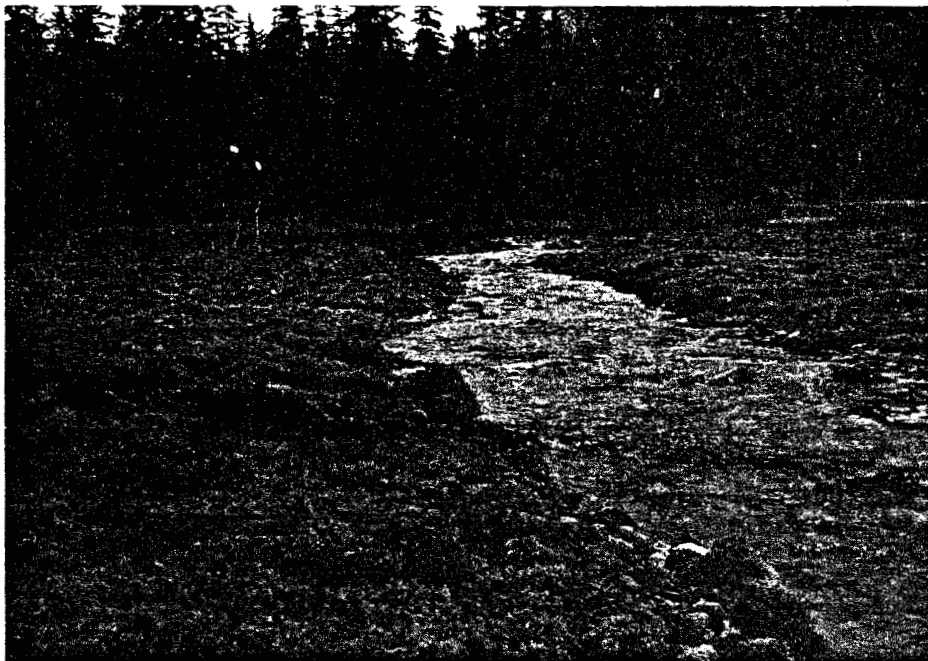
1. Compact boulders provide poor ASA in the ITZ

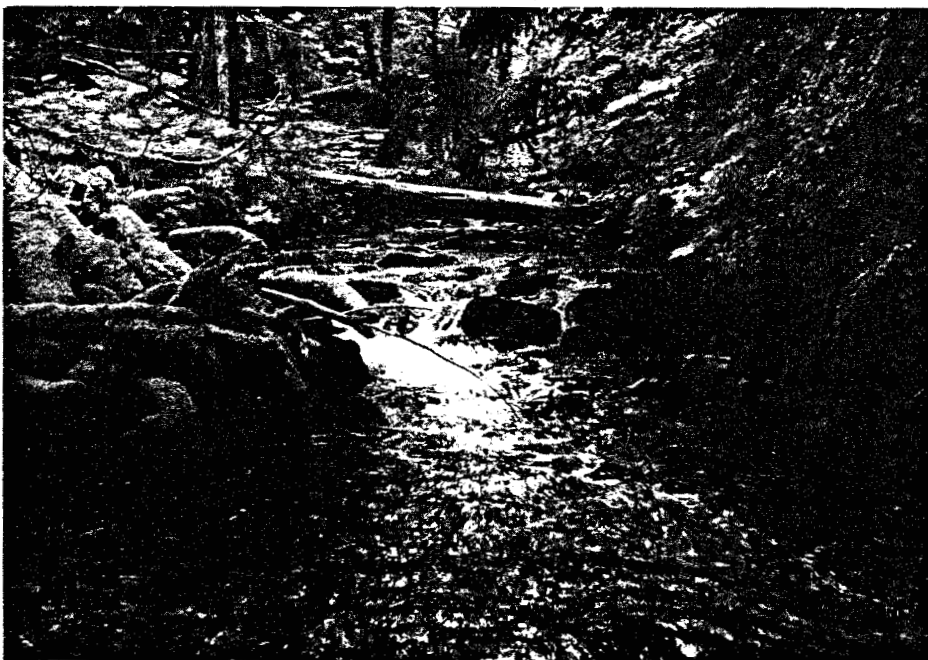
2. Section 2: The stream is characterized by large substrate and rather swift water

Section 2 cont. Rearing coho are observed but appear to be in low density.

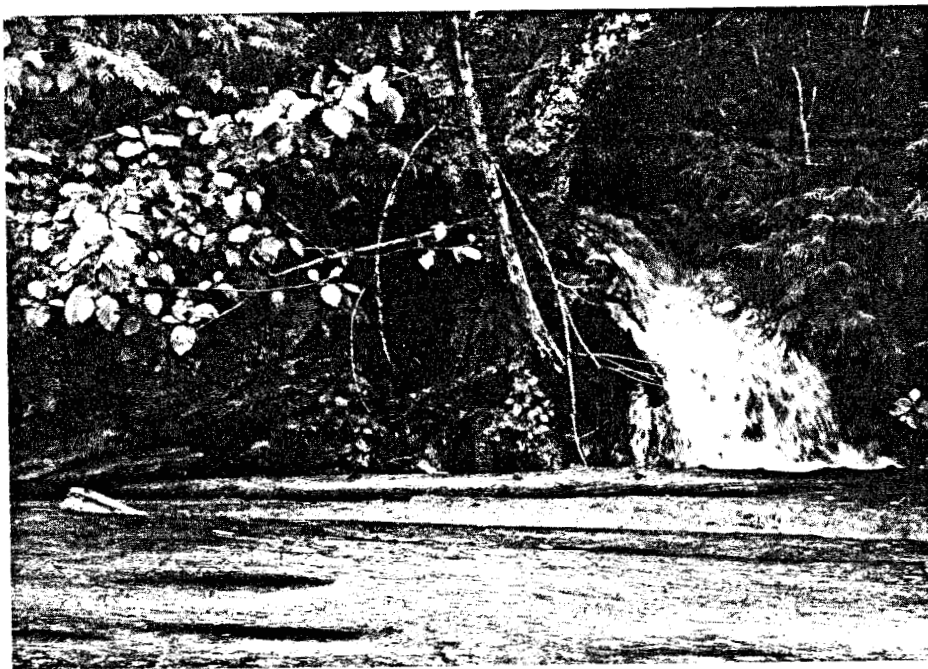
2. A potential 2 m. falls is present at the mouth
or the stream

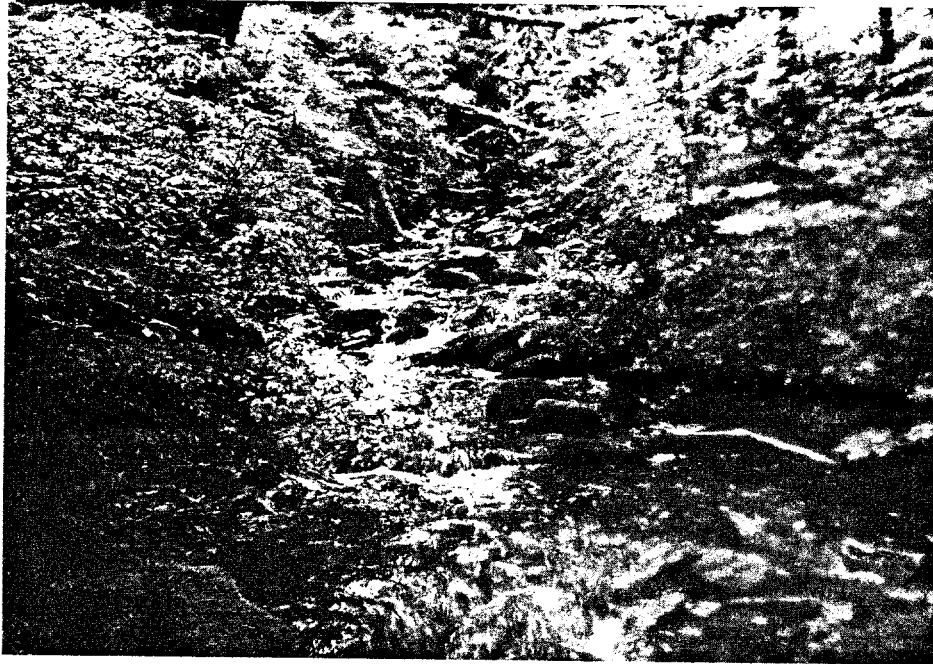
3. Typical habitat 50 m. from the ITZ

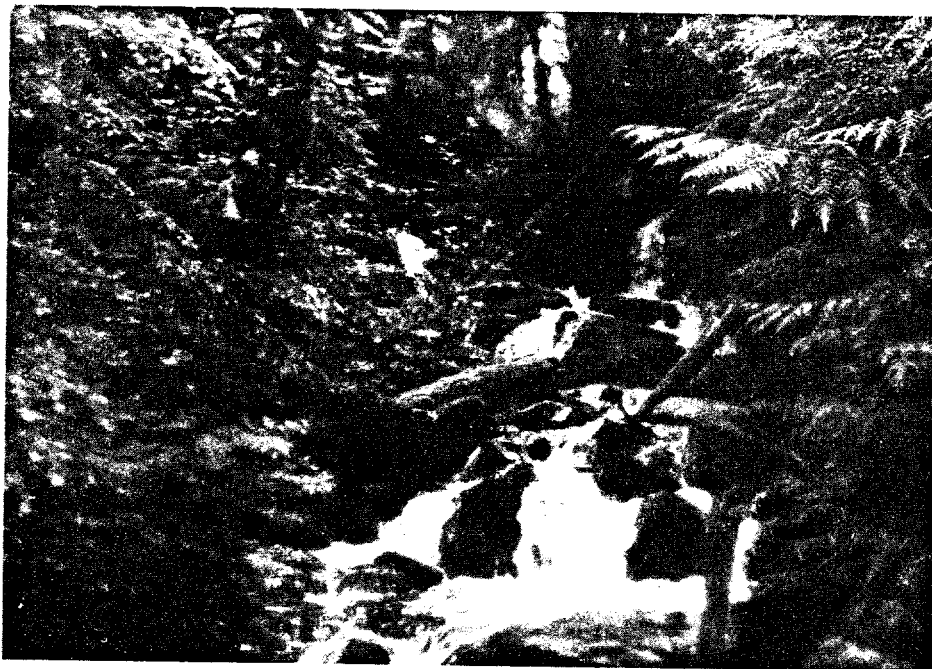
4. Potential barriers 200 m. above ITZ.

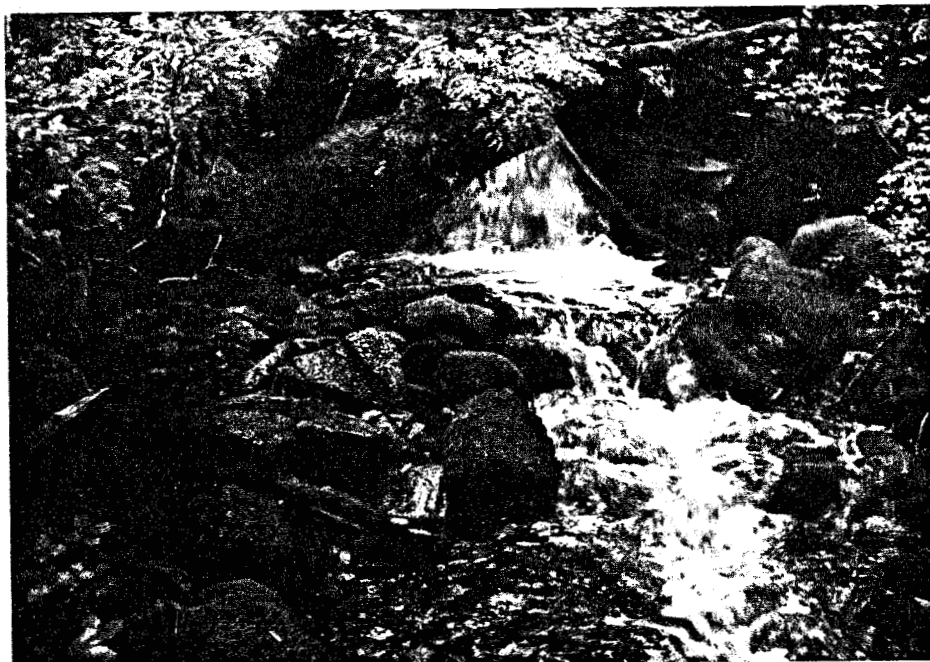
2. The gradient is over 20% 10 m. from the ITZ. The habitat remains minimal up to a barrier falls 90 m further.

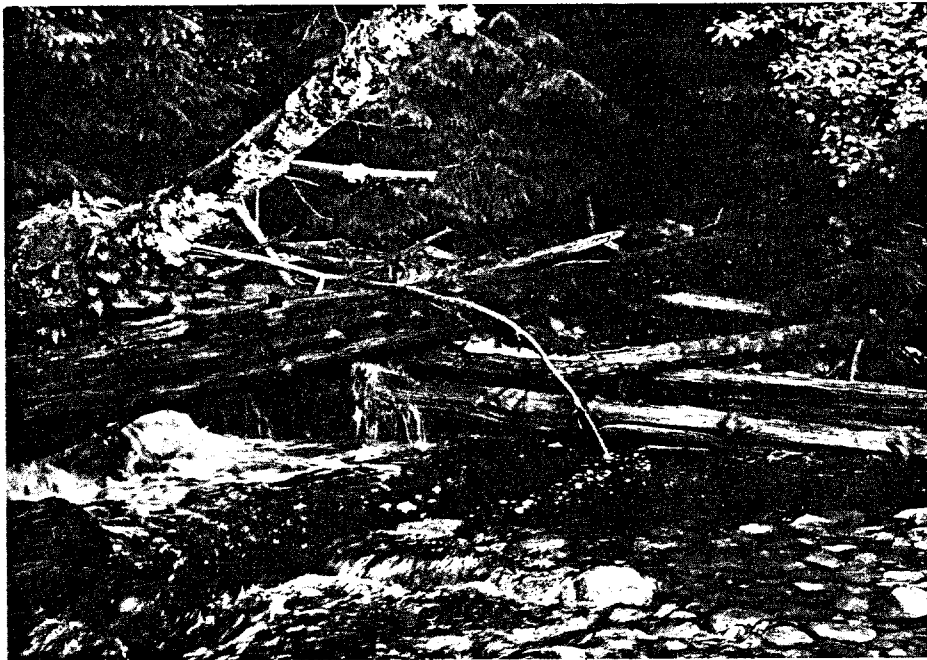
2. Debris obstacle present at the mouth of the stream

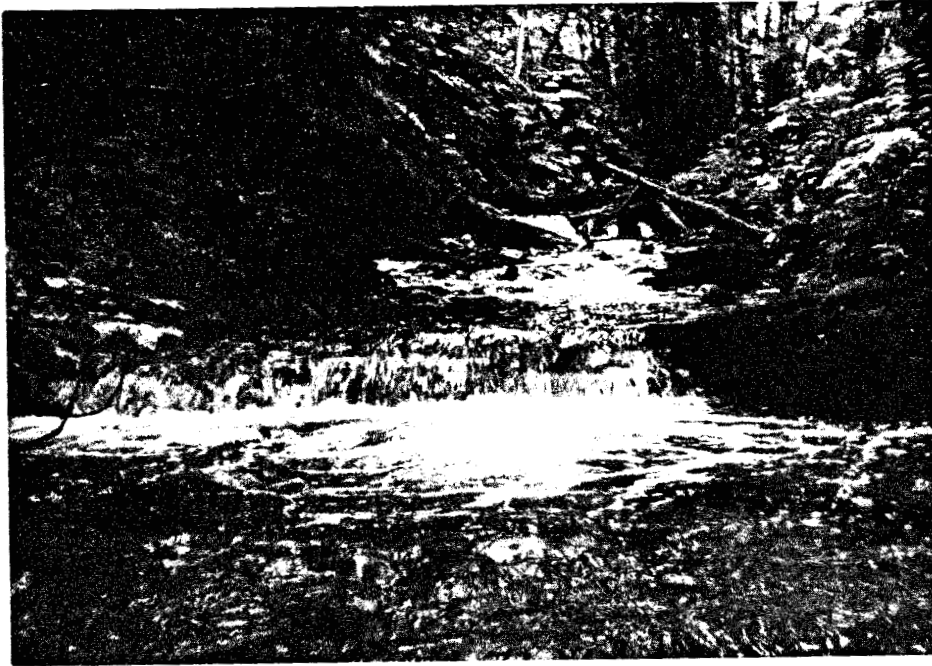
3. Section 2: Habitat typical of the entire survey area

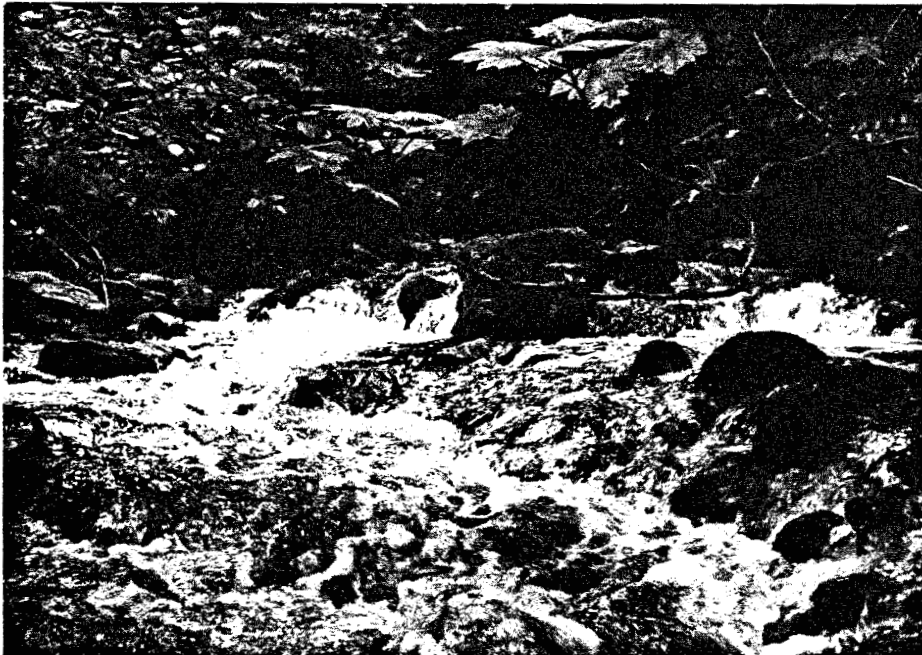
4. Whitewater in Section 8
